REPORT NUMBER: WI-04-03

**Truncated Warning Dome Systems for Handicap
Access Ramps**

FINAL REPORT NUMBER: WI-04-03
WisDOT Highway Research Study # WI-02-03

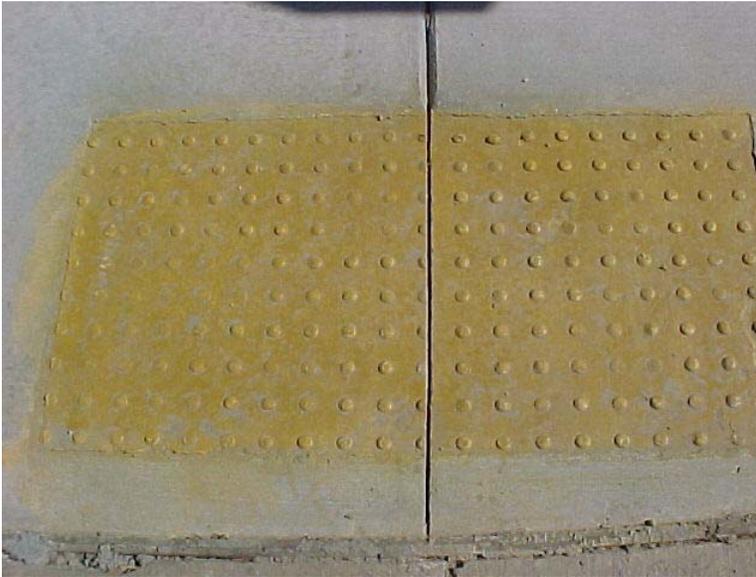
Site: no.1

The concrete stamp manufactured by Increte was used to install the truncated warning dome pattern at this site. Two ramps were installed, one on the west side, one on the east of this T shaped intersection.

Minor damage was experienced with snow removal operations

Conclusion: Not an effective system.

Recommendation: System not to be approved for use on Wisconsin Department of Transportation's projects.

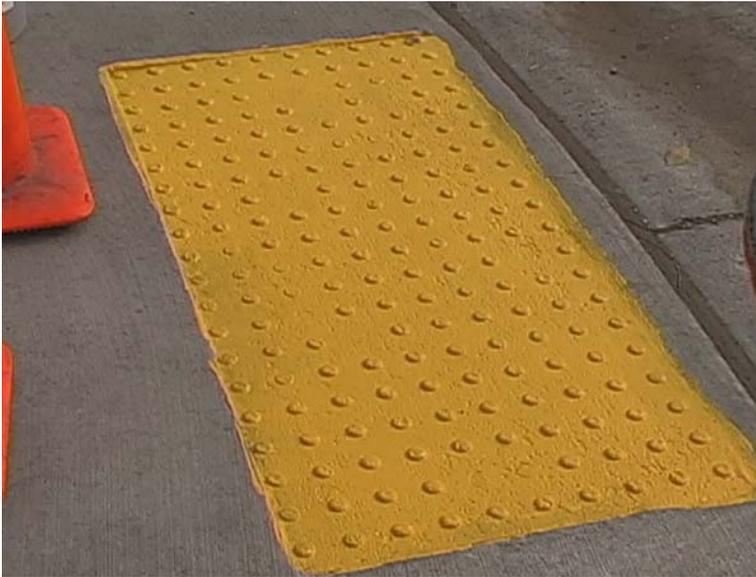
Site: no.4

First application of the release agent was done per the manufacturer's recommended procedure. First lightly spray the area to be stamped and the stamp it's self. This yielded a crazed consistency to the dome pattern. Too much liquid was introduced into the stamping process doing this. Next was tried a method where spray release was only applied to the stamp. This produced a better result but inconsistencies still remained in the formation of the domes.

This installation was painted with a waterborne paint in early November to provide the required contrast. By spring the paint had been worn away. This installation is in the University of Wisconsin – Madison campus and received foot traffic well before an appreciable cure for the paint had been achieved.

Minor damage from snow removal operations was encountered.

Conclusion: Not an effective system.

Recommendation: System not to be approved for use on Wisconsin Department of Transportation's projects.

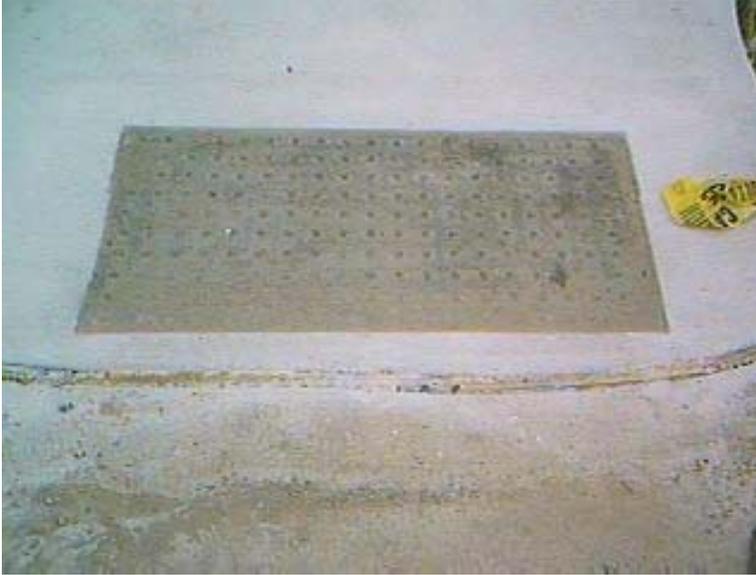
Location: Packers Ave. and Schlimgen Dr., Madison Wisconsin

No damage was evident from snow removal operations

Conclusion: Not an effective system.

Recommendation: System not to be approved for use on Wisconsin Department of Transportation's projects.

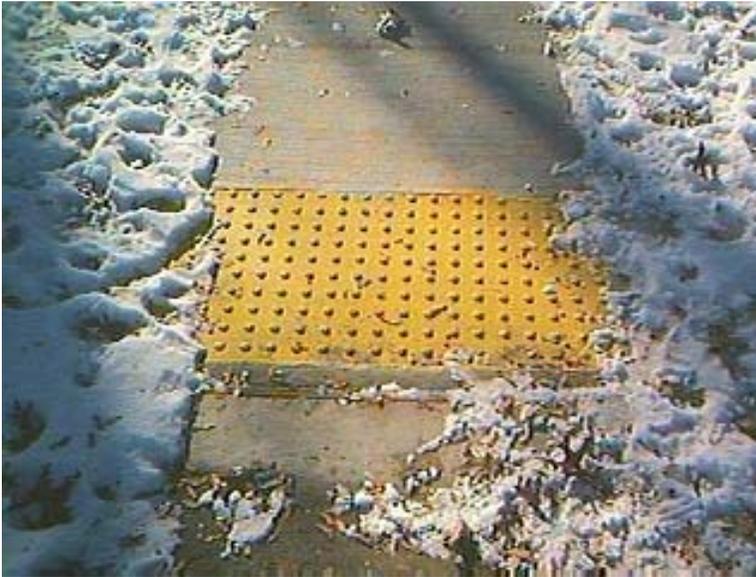
Location: Grandview Ave. – Sandwood Dr.
Madison Wisconsin

Minor damage from snow removal operations was encountered.

Conclusion: Not an effective system

Recommendation: System not to be approved for use on Wisconsin Department of Transportation's projects

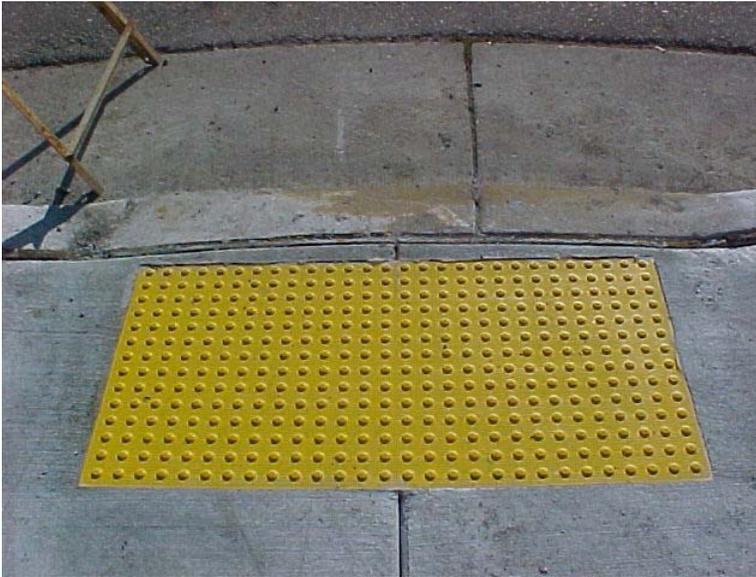
Location: Kinsman Blvd – Wright
St., Madison Wisconsin

No visible damage from snow removal operations.

Conclusion: An effective system

Recommendation: System approved for use on Wisconsin Department of Transportation's projects

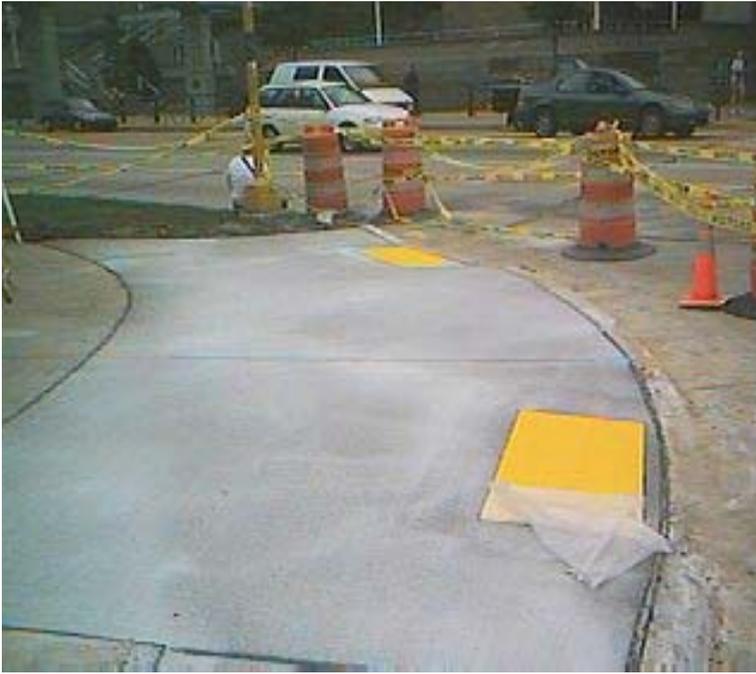
Location:
Park Street and University Avenue,
Madison Wisconsin

No damage was visible from snow removal operations.

Conclusion: An effective system

Recommendation: System approved for use on Wisconsin Department of Transportation's projects

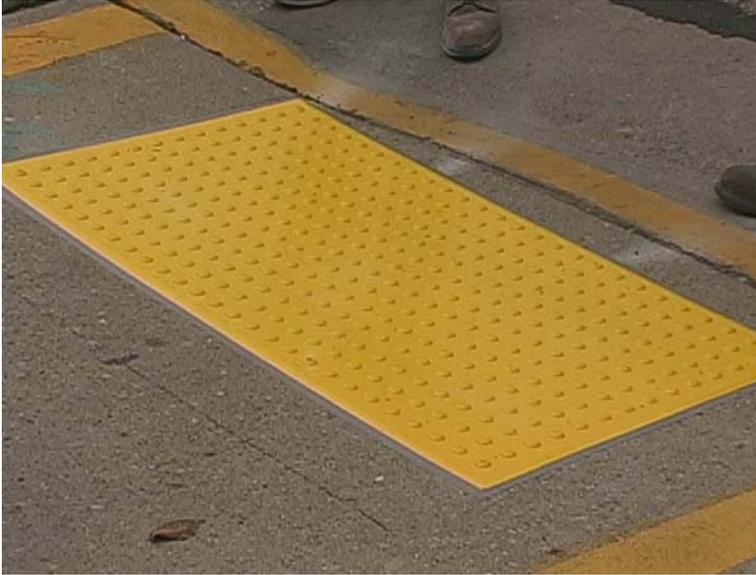
Site: no.7

Minor damage was experienced by snow removal operations.

Conclusion: An effective system but the department is opting for inset systems.

Recommendation: System not approved for use on Wisconsin Department of Transportation's projects

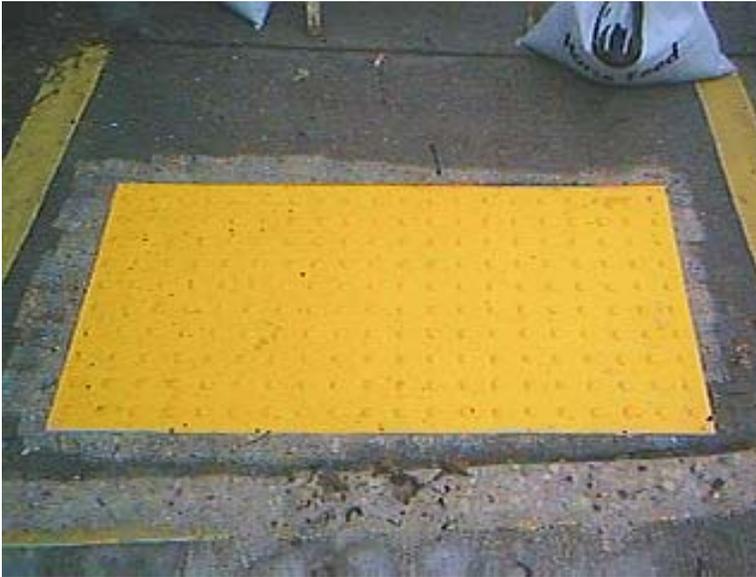
Location:
Gilman and Carroll Street, Madison
Wisconsin

The mats performed well in resistance to damage from snow removal operations and bonding to the concrete. Problems were seen with retaining dirt in the pores of the product giving the panels a dirty and stained look.

Conclusion: Not an effective system

Recommendation: System not to be approved for use on Wisconsin Department of Transportation's projects

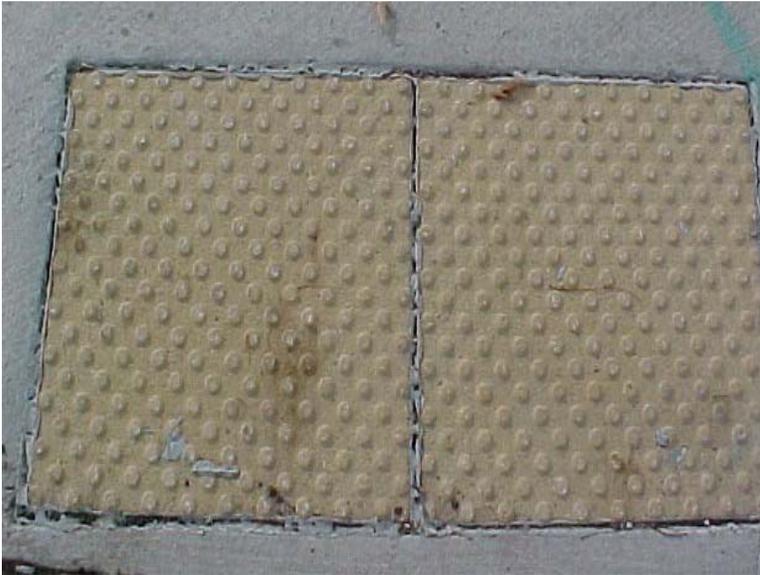
Location:
Kinsman Blvd. – STH 51, Madison
Wisconsin

The installation technique of the pavers make this system to cumbersome to install. The pavers themselves have performed well in resisting damage from snow removal operations.

Conclusion: Not an effective system

Recommendation: System not to be approved for use on Wisconsin Department of Transportation’s projects

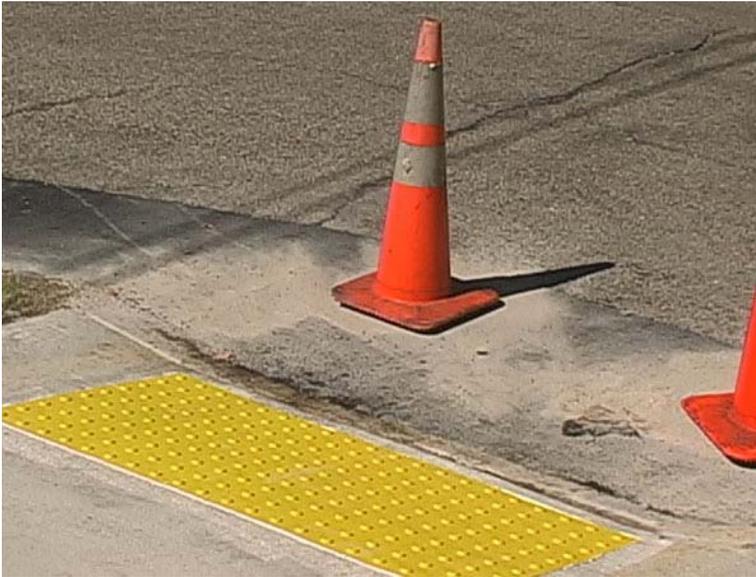
Site: no.3

Areas of debonding were evident after several days of the installation. The product was damaged past an acceptable level with snow removal operations.

Conclusion: Not an effective system

Recommendation: System not to be approved for use on Wisconsin Department of Transportation's projects

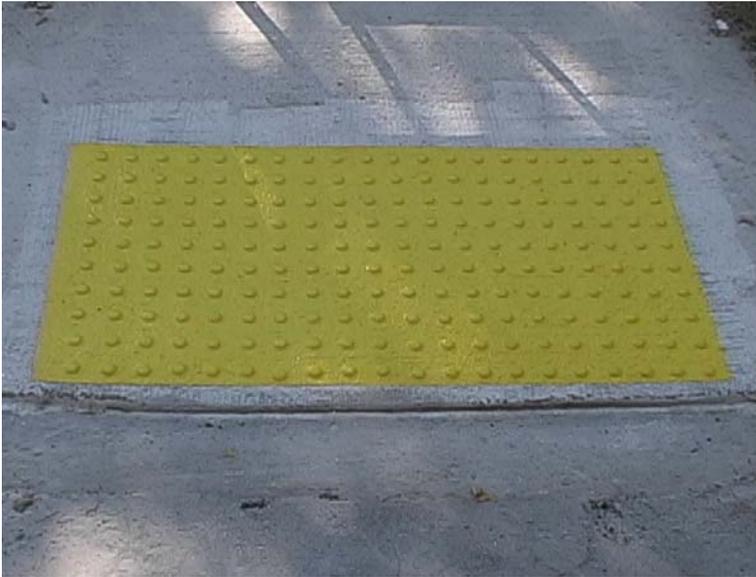
Location:
Keys Street – Prospect Street, Madison
Wisconsin

After the sheet material was removed a second coat of the Safti-Trax was applied and allowed to cure overnight. The next day a third coat of the field material was applied and allowed to cure for before traffic was allowed to traverse over the dome installation. The product was damaged past an acceptable level with snow removal operations.

Conclusion: Not an effective system

Recommendation: System not to be approved for use on Wisconsin Department of Transportation's projects

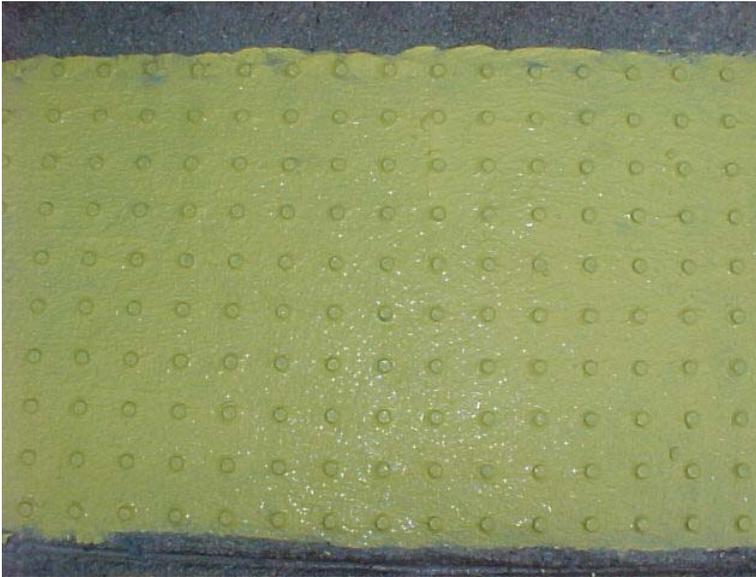
Location:
West Lawn and Harrison Street, Madison
Wisconsin

The sidewalk is scarified to clean the concrete. The concrete had any loose material removed and was then cleaned with compressed air. The concrete surface was then saturated with water to help the adhesion process of the mortar.

Several domes lifted off the concrete with the mat form. The domes were reattached using the first coat of field material. Domes were damaged from snow removal operations

Recommendation: System not to be approved for use on Wisconsin Department of Transportation's projects

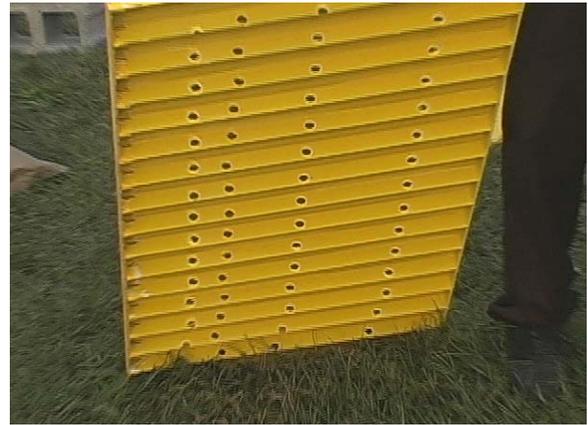
Holes in the ribs allow concrete to penetrate the ribs holding the tile in place. Vent holes at the top of each channel allow the air to escape in the installation process.

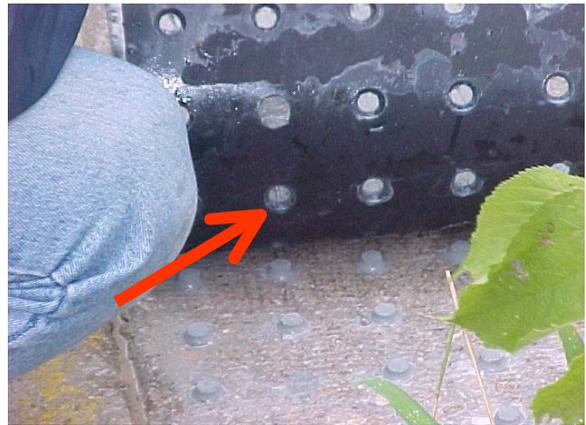
Some of the domes were pulled off with the form.

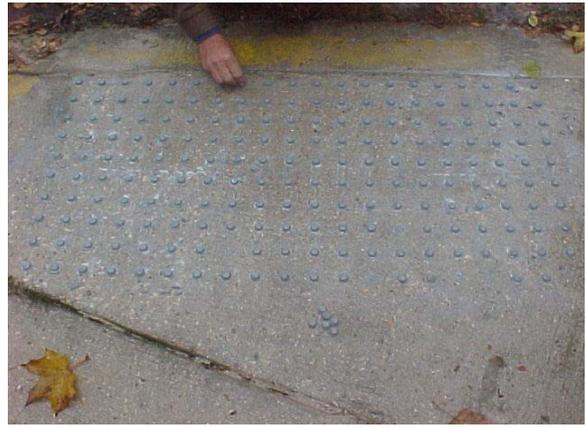
View of the product after the form was pulled. Notice that several domes did not adhere to the ramp.

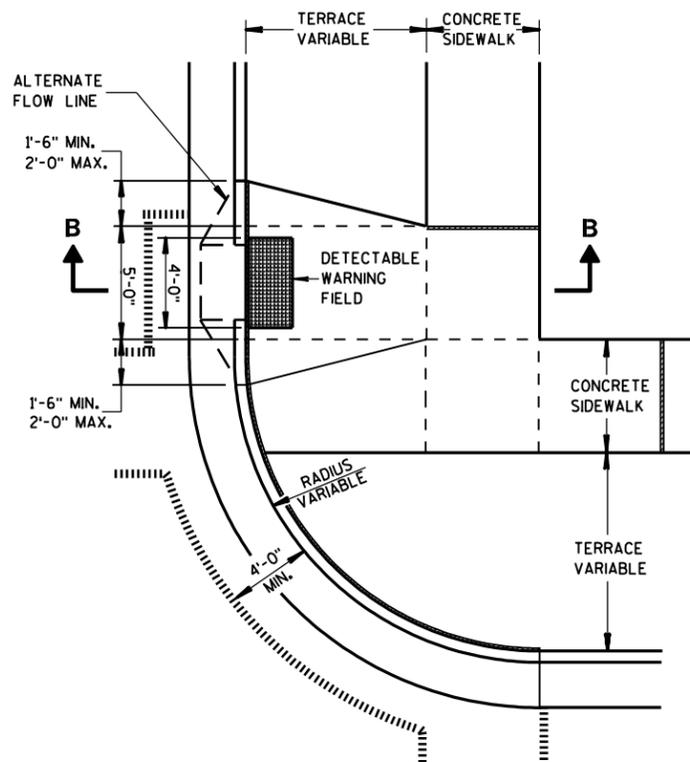
**PLAN VIEW
TYPE 3 RAMP**
(OUTSIDE OF CROSSWALK AREA)

USE THE TYPE 3 RAMP ONLY WHEN A TYPE 1 OR TYPE 2 CANNOT BE ACHIEVED BECAUSE OF FIELD CONDITIONS.
